DEPARTMENT OF TRANSPORTATION

Quality Assurance and Source Inspection

Contract #: 04-0120F4Cty: SF/ALA Rte: 80 PM: 13.2/13.9File #: 1.28**WELDING INSPECTION REPORT****Resident Engineer:**Pursell, Gary**Address:** 333 Burma Road**City:** Oakland, CA 94607**Report No:** WIR-016402**Date Inspected:** 23-Aug-2010**Project Name:** SAS Superstructure**OSM Arrival Time:** 700**Prime Contractor:** American Bridge/Fluor Enterprises, a JV**OSM Departure Time:** 1530**Contractor:** American Bridge/Fluor Enterprises, a JV**Location:** Jobsite**CWI Name:** See below**CWI Present:** Yes No**Inspected CWI report:** Yes No N/A**Rod Oven in Use:** Yes No N/A**Electrode to specification:** Yes No N/A**Weld Procedures Followed:** Yes No N/A**Qualified Welders:** Yes No N/A**Verified Joint Fit-up:** Yes No N/A**Approved Drawings:** Yes No N/A**Approved WPS:** Yes No N/A**Delayed / Cancelled:** Yes No N/A**Bridge No:** 34-0006**Component:** SAS OBG**Summary of Items Observed:**

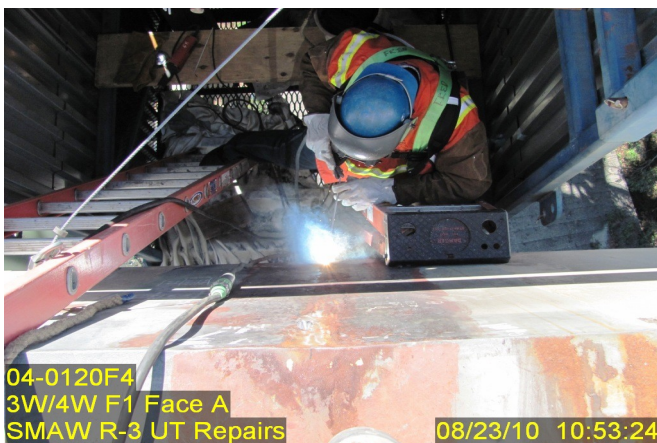
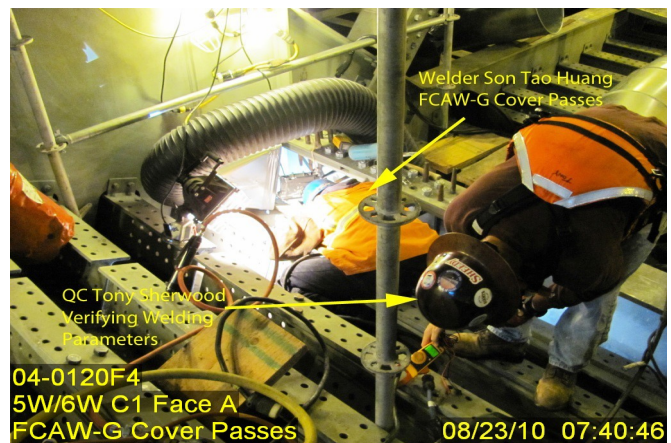
4). OBG Field Splice 5W/6W Weld ID: C2, Face A

The QAI periodically observed AB/F approved welder Song Tao Huang (ID 3794) performing welding per the Flux Cored Arc Welding (FCAW-G) process in the 3G (vertical) position of cover passes on the last 600mm of weld ID: C2. See photo below. The QAI observed QC Inspector Tony Sherwood was present to monitor the progress and verify that the welding parameters were within the limits established by the approved Welding Procedure Specification (WPS) identified as ABF-WPS-D1.5-3042B-1. The QAI observed that the work at this location was complete and appeared to be in general compliance with contract documents.
